# PRE-CONSTRUCTION INDOOR ENVIRONMENTAL QUALITY REPORT

### **Howard County Public School Systems**

October 19, 2017

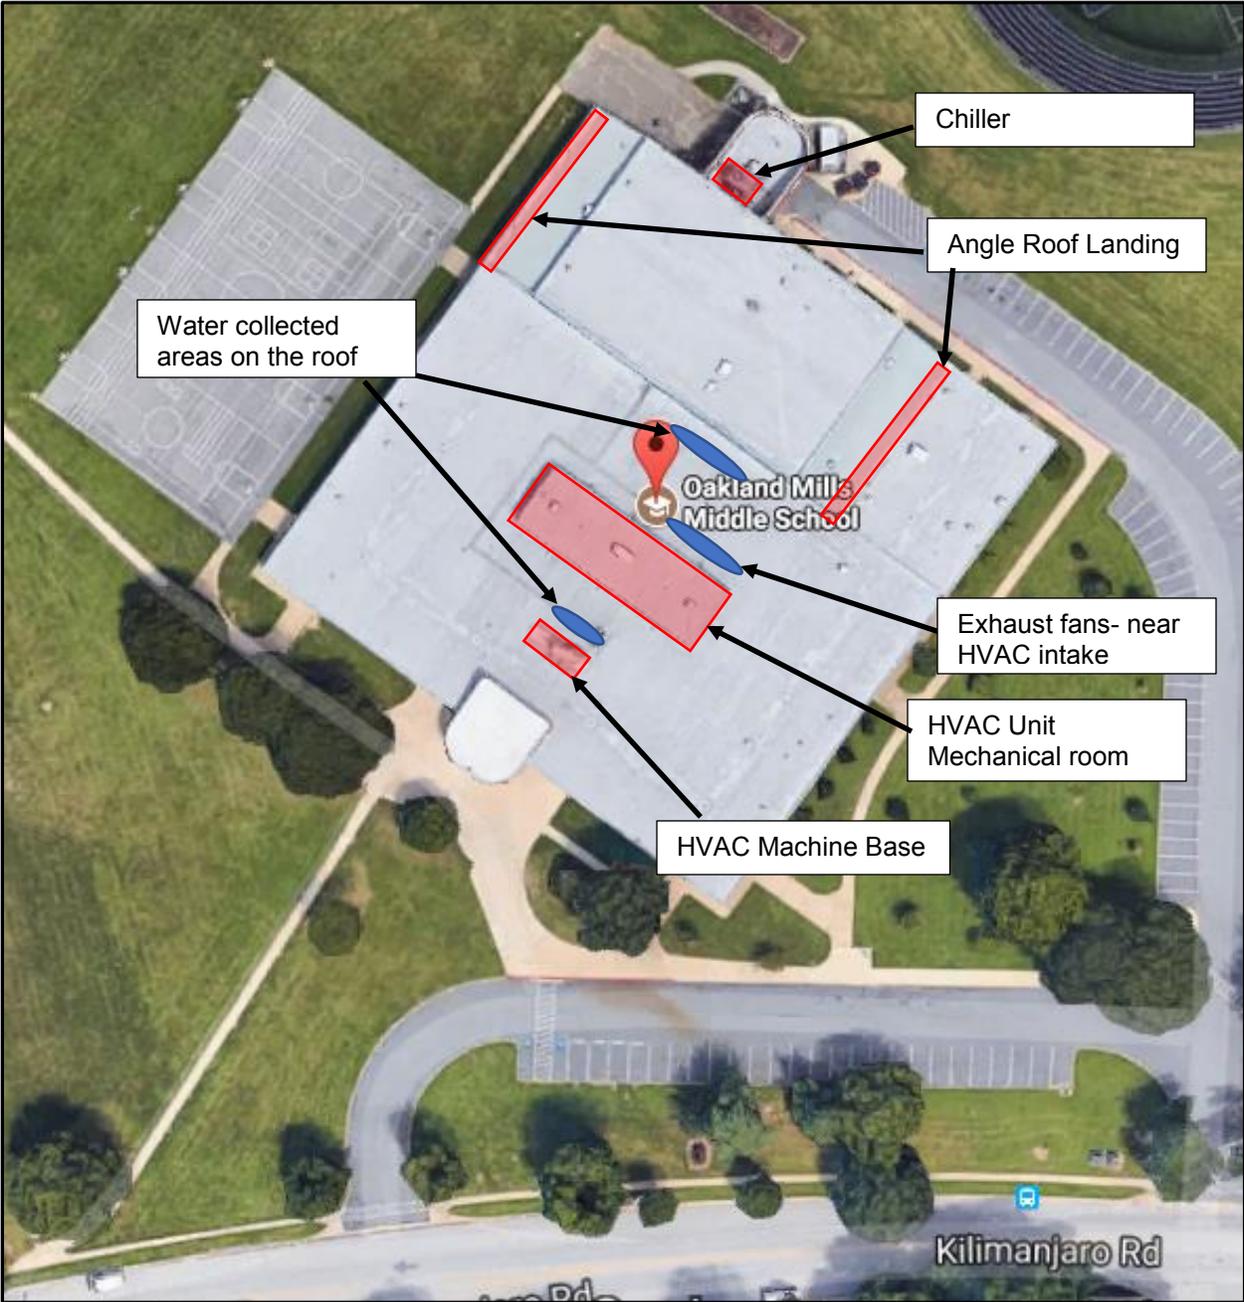
Appendix A: Affected Area Locations on the Roof

The Site was observed to be in good condition, no existing water intrusion were identified, but there were several areas of potential water intrusion observed on the roof within the roof insulation materials. Further evaluation is recommended by a licensed contractor (roofer) to assess the sealant around the roof penetration areas for the plumbing system, drain point, patch repair, flashing, and cracks and overlap sealant within the rubber roofing membrane components. Suspected mold growth was visible on the roof near the Heating, Ventilation, and Air Conditioning (HVAC) air intakes, Pipe Insulation (PI) in all the HVAC machine room located on the roof of the school, and top of the HVAC ceiling diffusers above the drop ceilings throughout the school building. There were moderate to heavy dust accumulations on above the ceilings. Occupants were not directly exposed to suspected mold growth areas or dust surfaces.

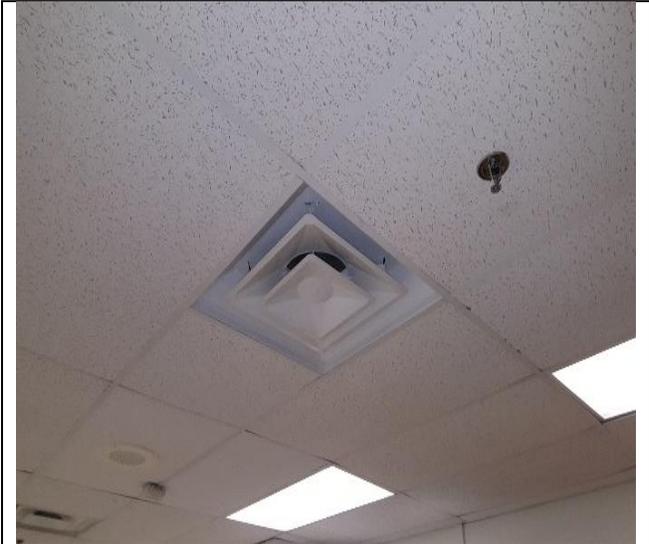
Photo 1: AC diffuser from inside a room

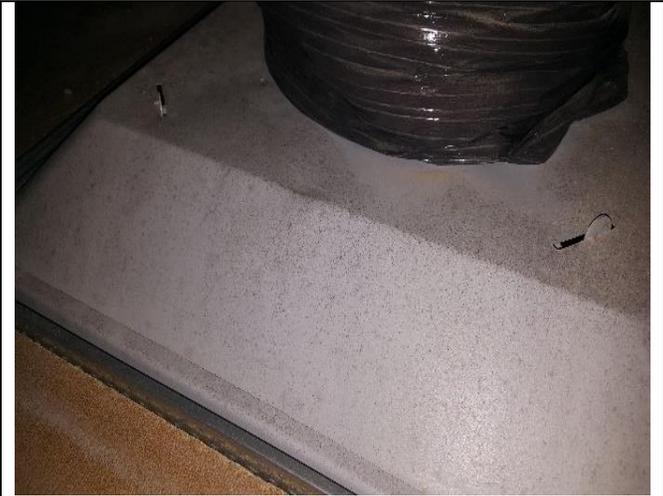
SaLUT crew observed suspected mold growth on the metal plates over the A/C diffusers above the ceilings throughout the building. 95% of the AC diffusers were affected with the suspected mold due to the coldness and the moisture generated with the cold air flow through the diffuser. Dust was also observed throughout the school in unreachable areas such as over the ceiling and boiler room. Ceiling tiles in the dropped ceiling throughout the school building showed general signs of sagging but were observed dry

Photo 2: AC diffuser from above the ceiling

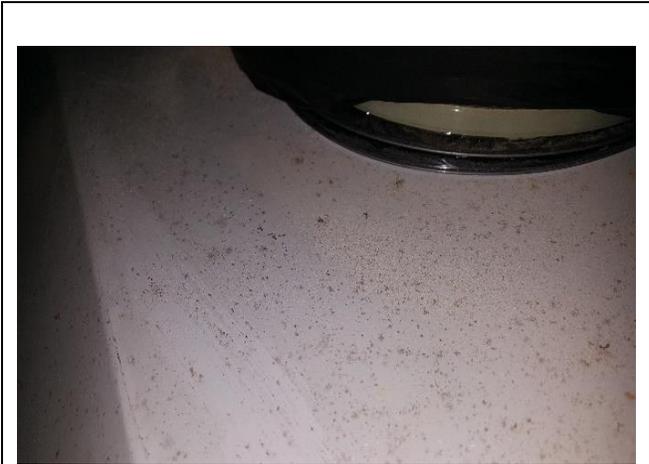
Photo 3: Suspected mold growth on AC diffuser

1. Cleanup on suspected mold growth areas following specifications described in section 2.3.
2. Mechanical engineer(s) are evaluating the HVAC systems serving the school to ensure operation will control summer humidity levels within ASHRAE guidelines.

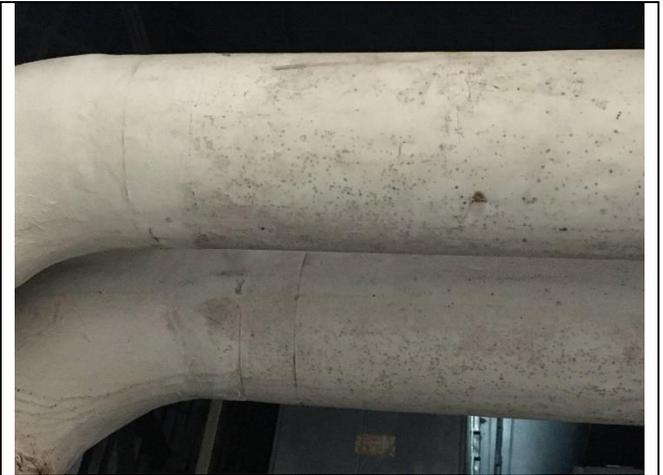
Photo 4: Suspected mold growth on Pipe insulations in HVAC machine room

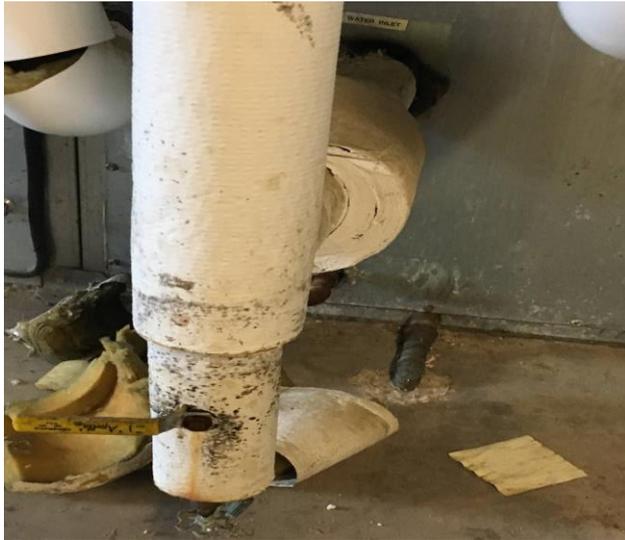
Photo 5: Suspected mold growth on Pipe insulations in HVAC machine room

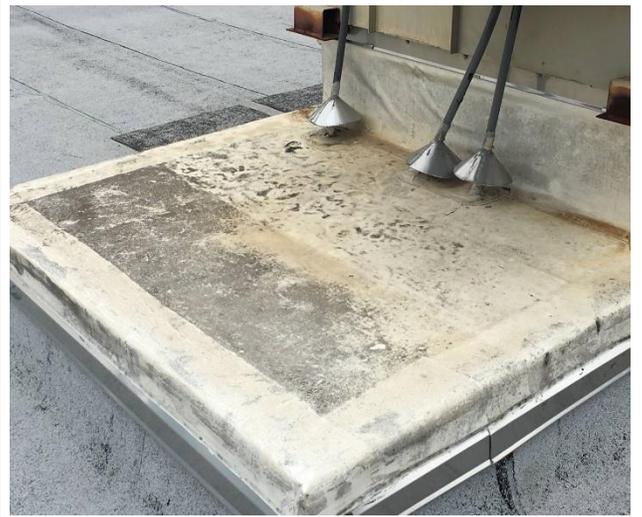
Photo 6: Suspected mold growth on HVAC machine base area

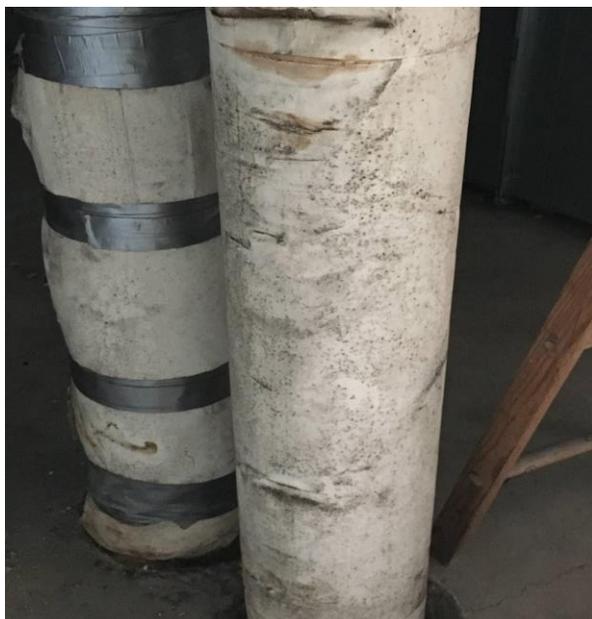
Photo 7: Suspected mold growth on Pipe insulations in HVAC machine room

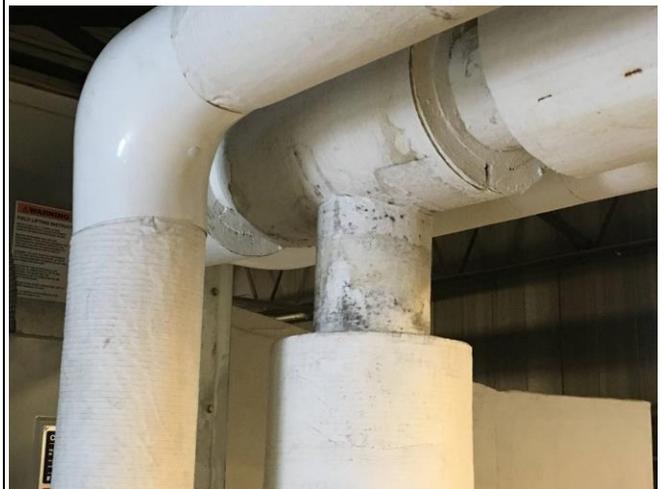
Photo 8: Suspected mold growth on Pipe insulations in HVAC machine room

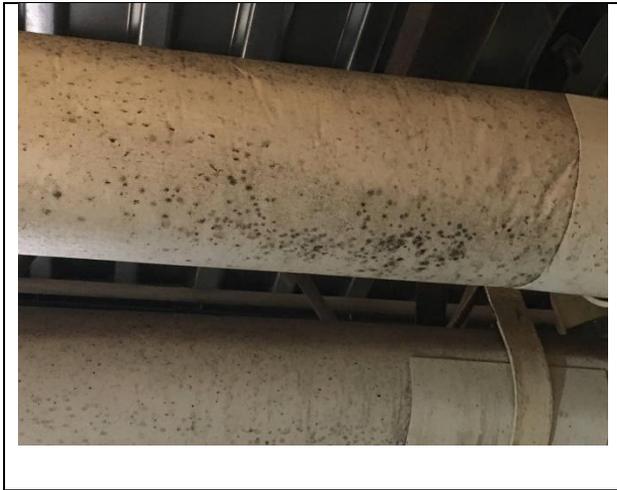
Photo 9: Suspected mold growth on pipe insulations in HVAC machine room

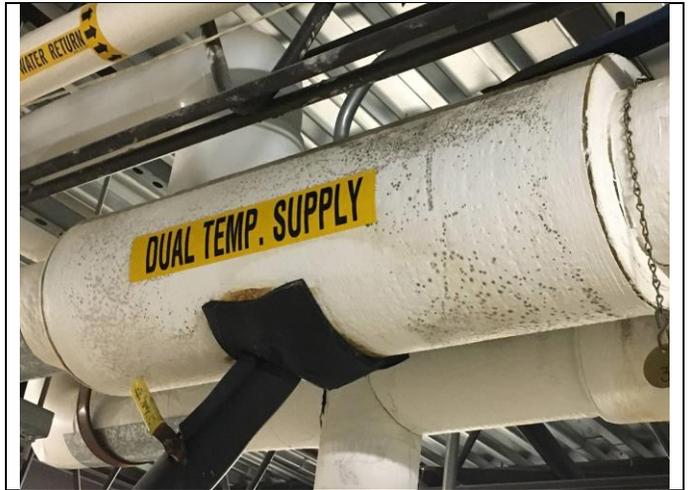
Photo 10: Suspected mold growth on pipe insulations in HVAC machine room

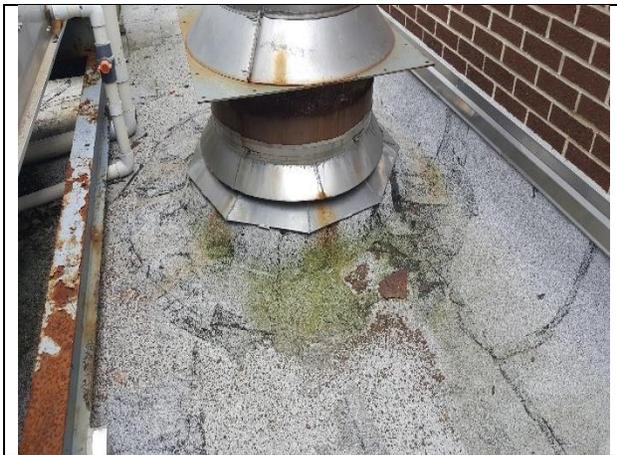
Photo 11: Suspected mold growth on the roof

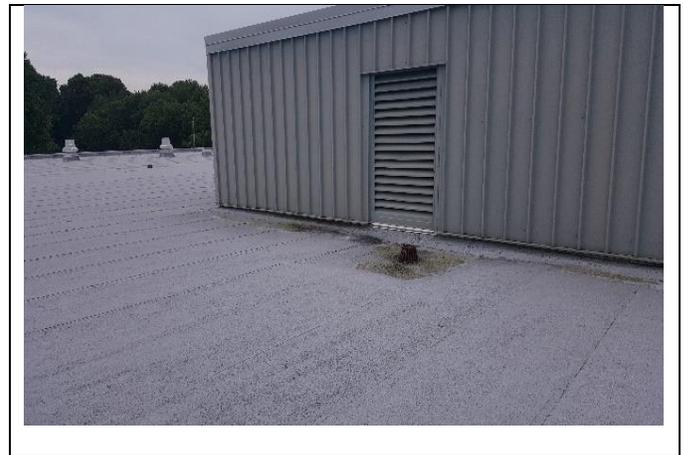
Photo 12: Suspected mold growth on the roof

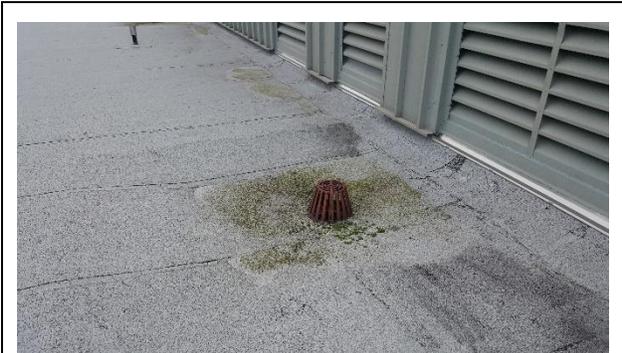
Photo 13: Suspected mold growth on the roof

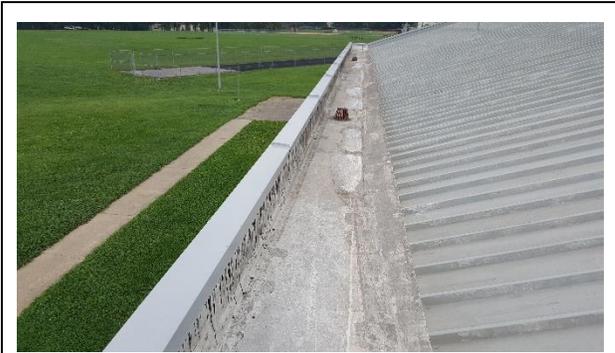
Photo 14: Suspected mold growth on angle roof landing area

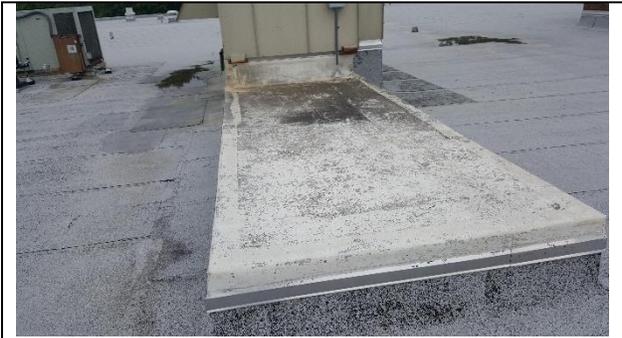
Photo 15: Suspected mold growth on HVAC machine base area

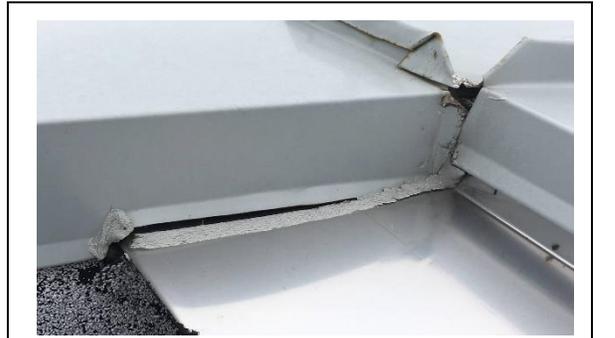
Photo 16: Representative location for roof flashing joint cracks

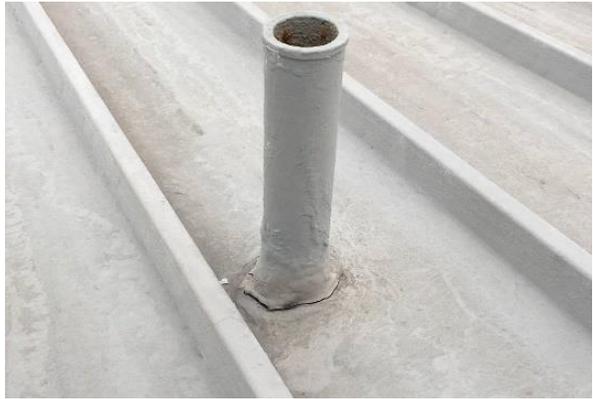
Photo 17: Cracked sealant at the roof penetration point area

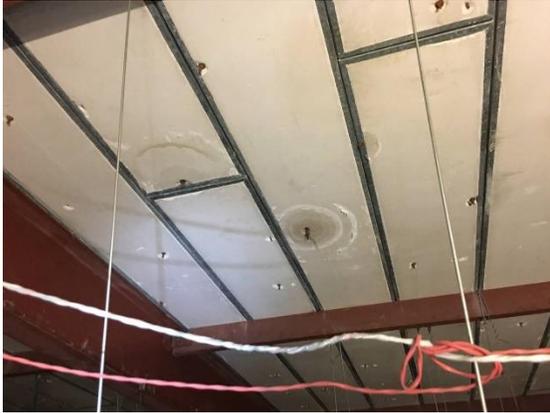
Photo 18: Roof penetration point where signs of water intrusion
